2008-09-18 Pbar Department Meeting

- Downtime, Gap
 - Part 1 - Li Lens failure
 - 10mm-3: 2nd stripline,

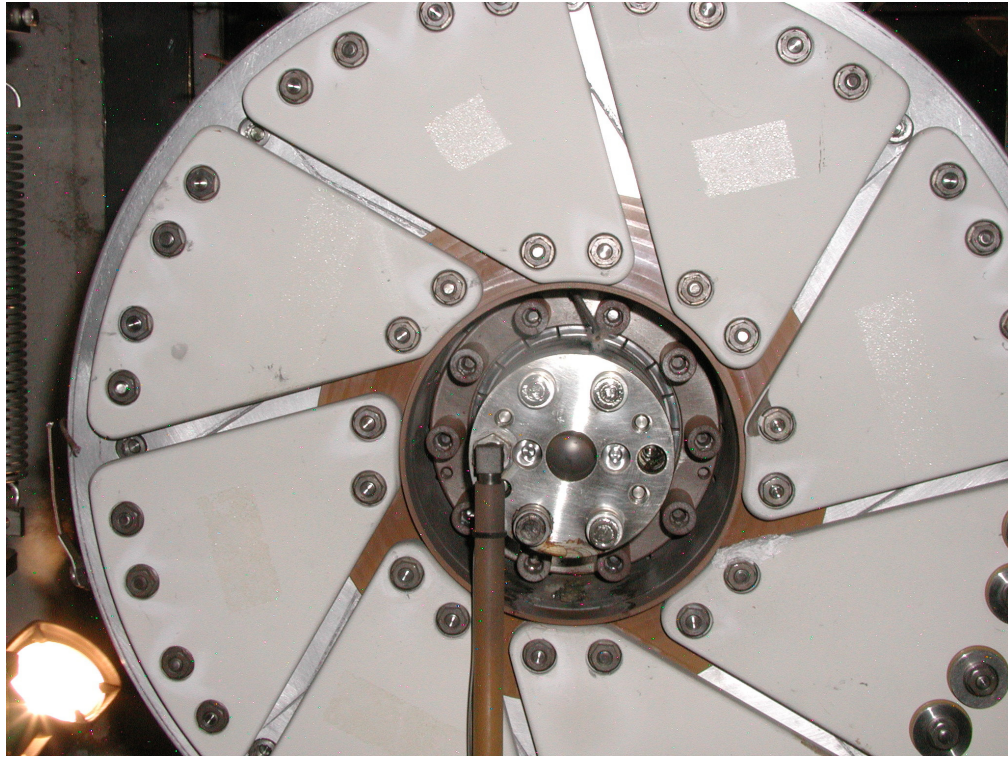
- Water stain on bottom, evidence of water leak and water hitting the housing.

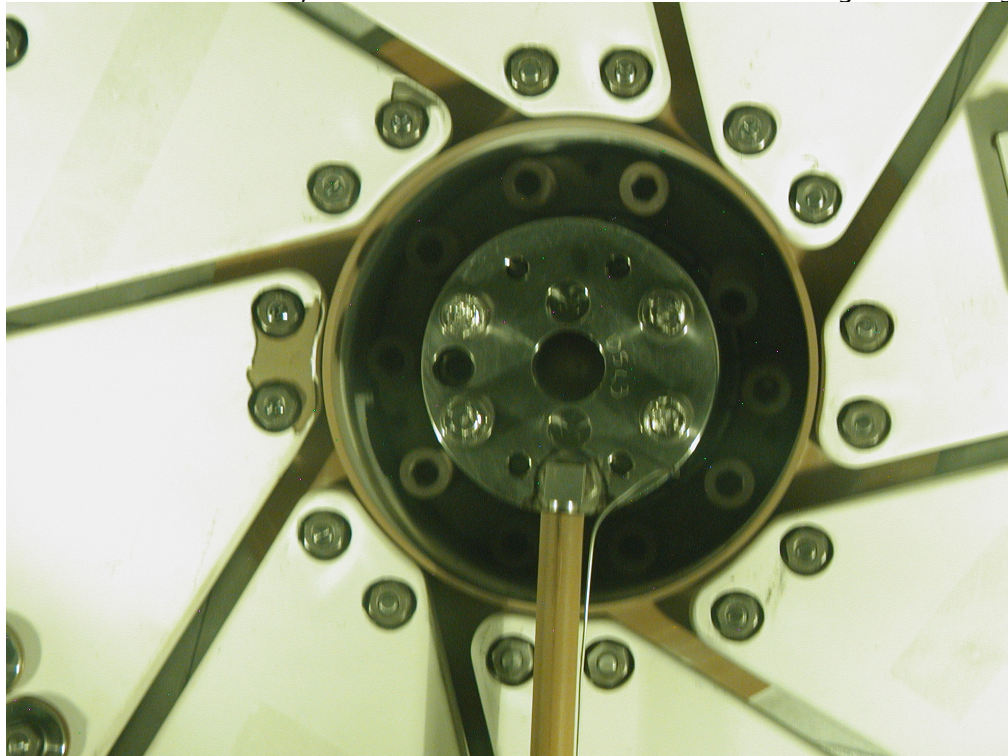
- It is thought that the leak is coming from the VCR fitting connection (at bottom).
- So Ryan is looking to redesign this fitting.

- So Ryan is looking to redesign this fitting.
 - Not certain that this water is the cause of the ground fault.
 - Also had lots of rain, the humidity is high. Condensate drain backs up due to biological growth, making big puddle. - fixed with two quarts of bleach.
 - High humidity may have contributed to failure.
 - Also on picture above, the bolt on the clamp ring is missing (2:00 on the plot in the shaded area).
- 10mm-5 was installed.
 - Part 2: A6Q6 - ground water was dripping on magnet causing ground fault.
- LCW leak

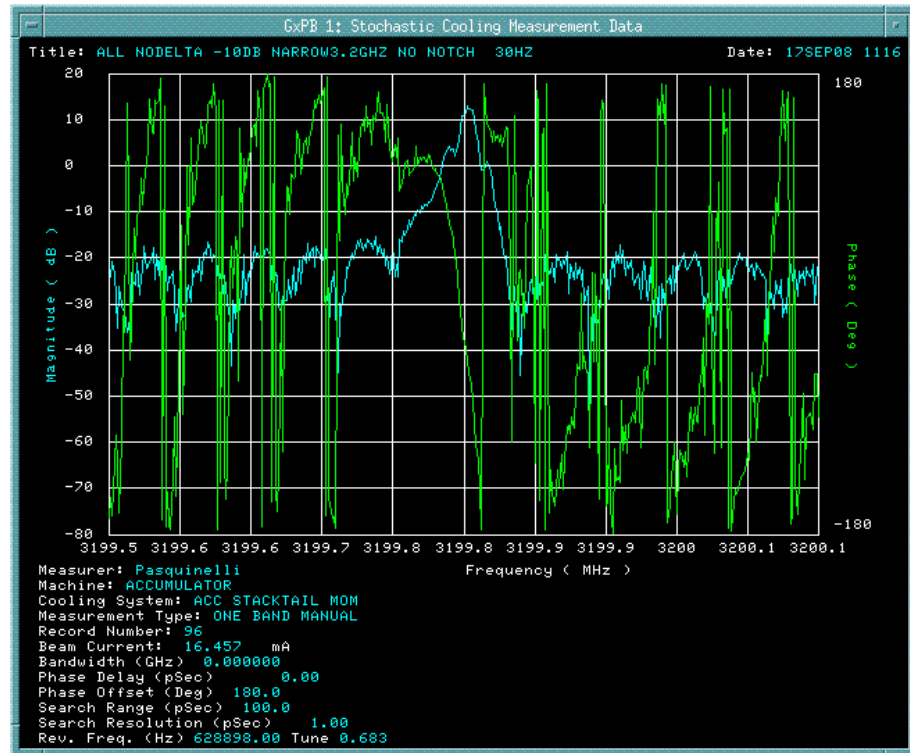
- Narrow band measurement
- Center peak is rev. harmonic
- Cannot see betatron sidebands.
- All ST TWTs are on here.
- Doing a TFM through those, to measure transverse excitation of the core by the stacktail delta kickers.

- Since no sidebands, there is nothing for the delta kickers to correct.
- So at the present time, there is no need to proceed with the equalizer for the delta kickers.
